A55 Cliff Gardens Bridge, Old Colwyn, Colwyn Bay

TERRY DAVIES, QUADRIGA CONCEPTS

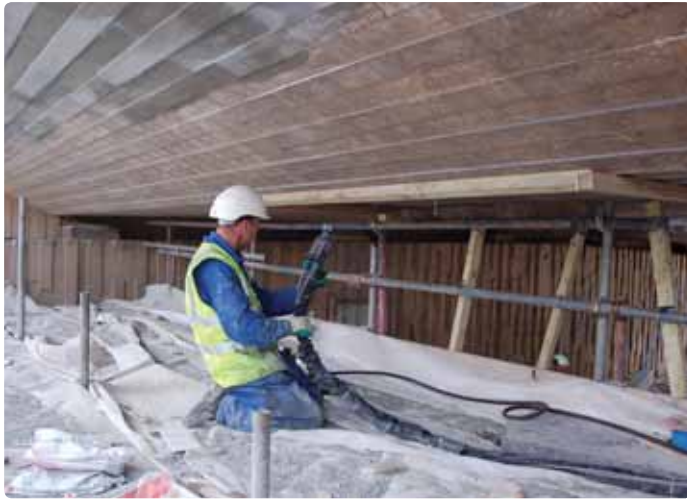
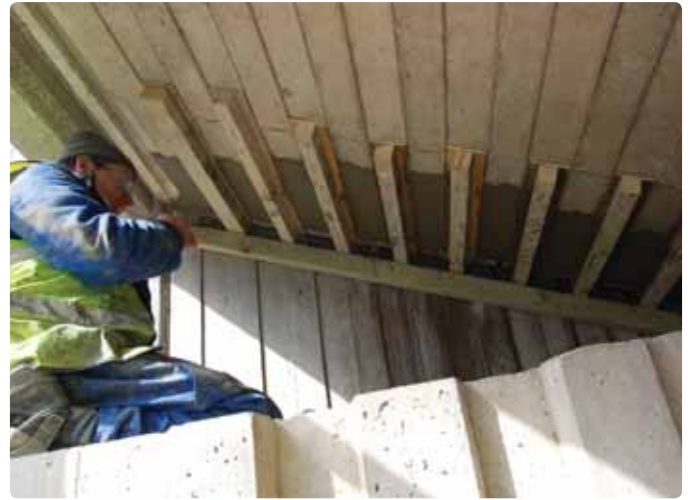
Figures 1 and 2 above: Concrete repair operations to soffit of bridge.

The concrete repairs on the structure were carried out in a traditional manner using cementitious materials applied by both cast and hand-placed techniques depending upon the extent, type and location of the damage. Removal of damaged and defective material was carried out using hydro-demolition and the wastewater was filtered, dosed with carbon dioxide and checked for water quality prior to being discharged into the adjacent watercourse. The exposed steel reinforcement was cleaned and primed immediately before application of the repair materials. The cast-on material was used in the case of a

particularly large repair to the retaining wall adjacent to the Afon Colwyn. Elsewhere, hand-placed repairs were used due to the intricate nature of the repairs where existing profiles were exactly recreated.

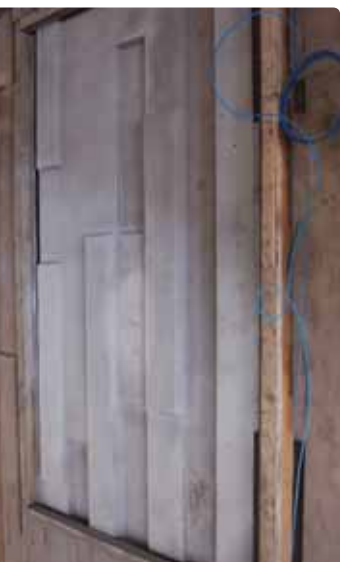
Figure 3: Trial CP area using thermal arc spray material.

The galvanic cathodic protection trial is a revolutionary method that uses a wire comprised of an alloy of aluminium, zinc and indium. This material is designed as a sacrificial anode, which is spray-applied onto the surface of the concrete using a thermal arc system. To complete the circuit, an electrical connection is made between the

steel reinforcement and the applied anode using a bolted connection to the steel and a zinc plate at the surface. This system has had extensive successful use in the USA and on a number of particularly large projects in the UK.

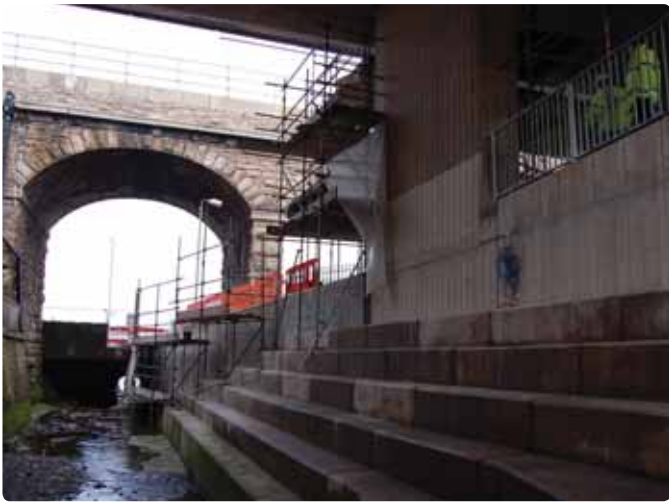
Figure 4 above left: Concrete repair operations to retaining wall within Afon Colwyn.

Due to the level of damage and the extent of chloride ion contamination from contact with the seawater, it was obvious that the only long-term remedial solution to the damage to the retaining wall, adjacent to the Afon Colwyn, would be to install an impressed current cathodic protection system. A ribbon anode system has been installed in this part of the structure, embedded in either repaired areas or chases cut into the wall itself.

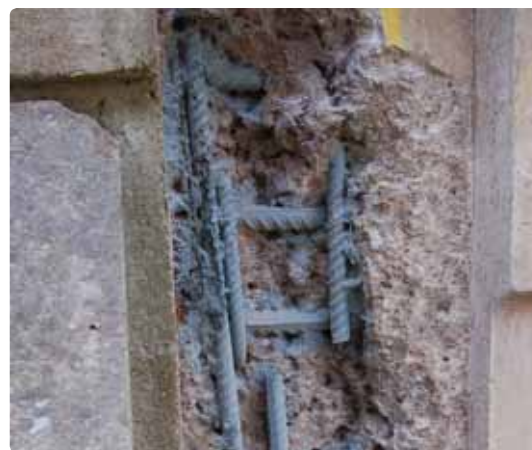
Figure 6 left: Prepared steel within repair area to abutment.

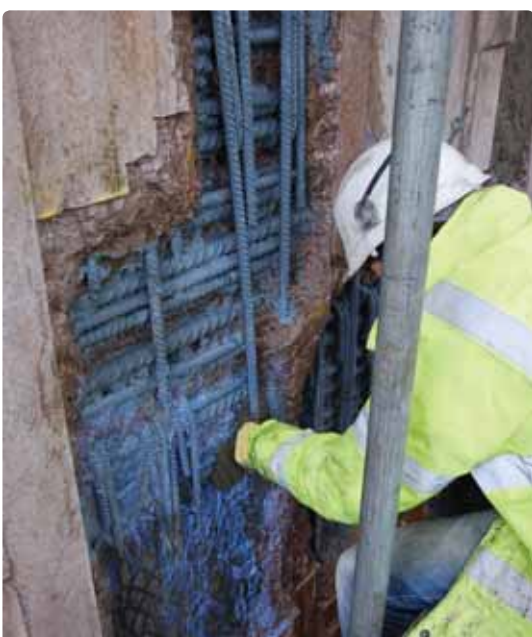
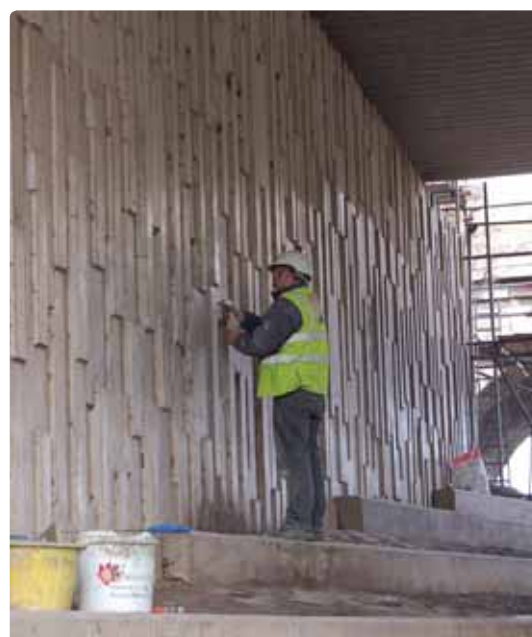
Figures 7 and 8 left: Concrete repair operations to figured abutments.
