Quadriga takes on repeated vandalism on war memorial

The local landmark on the main road in Moulton, Cheshire, is a valued piece of history recording the lives of the Moulton men who paid the ultimate sacrifice during two world wars.

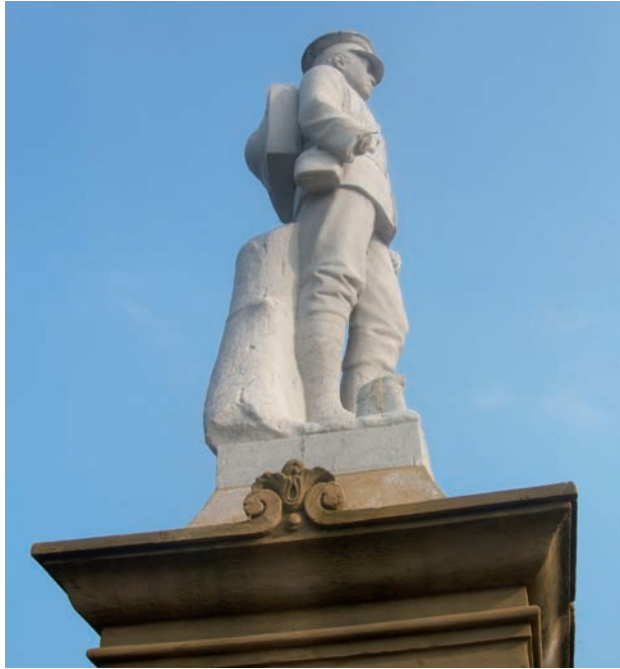
Picture One

Picture One: The Vandalised War Memorial without its arm and gun.

For a second time in March of this year, Quadriga, the refurbishment and restoration specialist based in Northwich, Cheshire, was commissioned to repair and renew sections of the figure. Extensive restoration work was needed on the arm and on the gun of the soldier, this involved drilling and inserting 6mm diameter stainless steel dowels which were set in epoxy resin well into the fractures. Once the arm and the gun had been recreated then all evidence of the repair work was painstakingly reinstated to match the existing surrounding stonework.

The skills of the Quadriga specialists were deployed on all aspects of the statue, each step of the process undertaken with painstaking accuracy and attention to detail including cutting back decayed or otherwise defective areas of stonework on the main damaged stone block where the names of the men who lost their lives are engraved.

All the vandalised areas of the statue's stonework were progressively restored using lightweight polymer repair mortar and finished with a wooden float to the original profile.

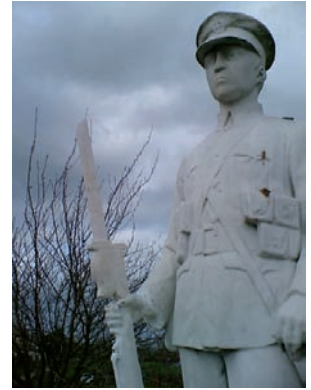
Picture Two

Picture Two: The Moulton War Memorial fully restored.
