After utter devastation – Quadruga begins restoration at Carleton Hall, Holmrook, Cumbria.

RESTORATION AND CLEANING

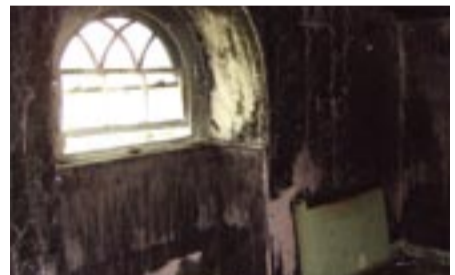
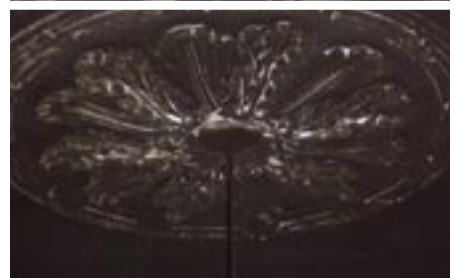
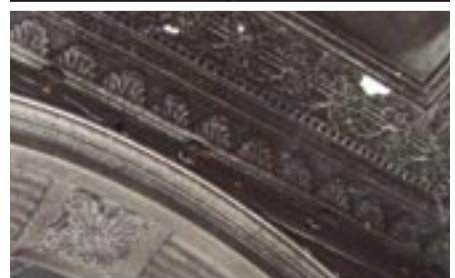
In June 2008 a blaze ripped through the 200-year-old north wing extension of Carleton Hall, which is a Grade 11 Listed Building constructed in the 17th century. A large section of the building is now uninhabitable and it is estimated that due to the damage encountered, it will take in the region of 7 months to restore. Luckily the south wing was not severely affected by the fire, and despite considerable smoke damage, the owners Mr and Mrs Fisher have been occupying this area.

Quadruga will commence the works by reinstating the roof structure which was completely destroyed by the fire.

At the same time we will be constructing the new oak king post truss in a temporary tented workshop within the grounds of the building. Once the truss has been fabricated, the existing system scaffold and sheeting, presently in place to protect the building, will be removed. Independent scaffolding will then be erected to the perimeter of the north wing and a crane will be brought to site to lift the truss into place. The crane will then be utilised to lift and position the other oak roof components, such as the purlin's, brace's and rafter's all of which are extremely heavy when compared to today's more modern equivalents.

The roof structure will then be covered in Westmorland slate, which is the original material used on this roof and the remainder of the building. The cast iron rainwater disposal system which escaped relatively undamaged will also be repaired at this point.

The render to the external walls and chimneys, will be removed and various structural repairs undertaken, prior to being replaced in traditional materials. The sash windows to ground and first floor levels will also be replaced at this time.
